## HO-2

## Oakdale

### **Architectural Survey File**

## National Register of Historic Places Registration Form

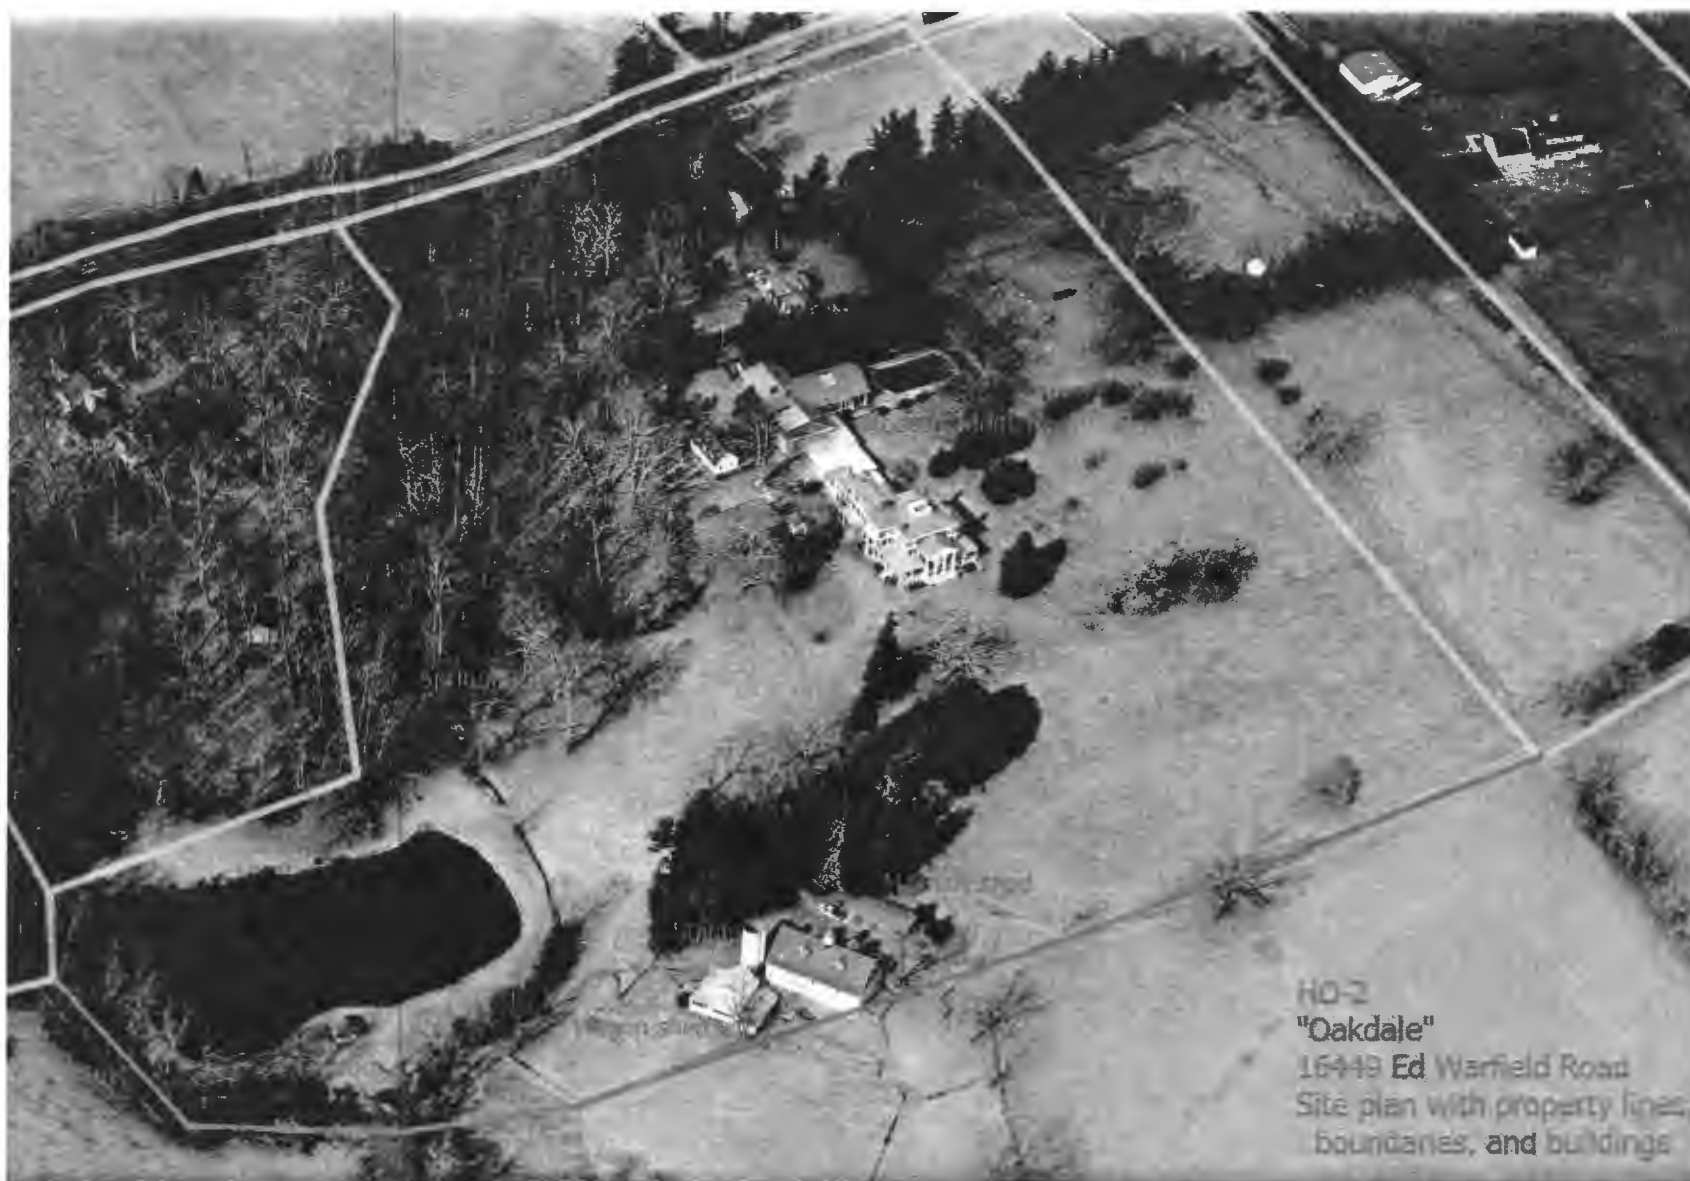
HO-2

Site Plan (not to scale)

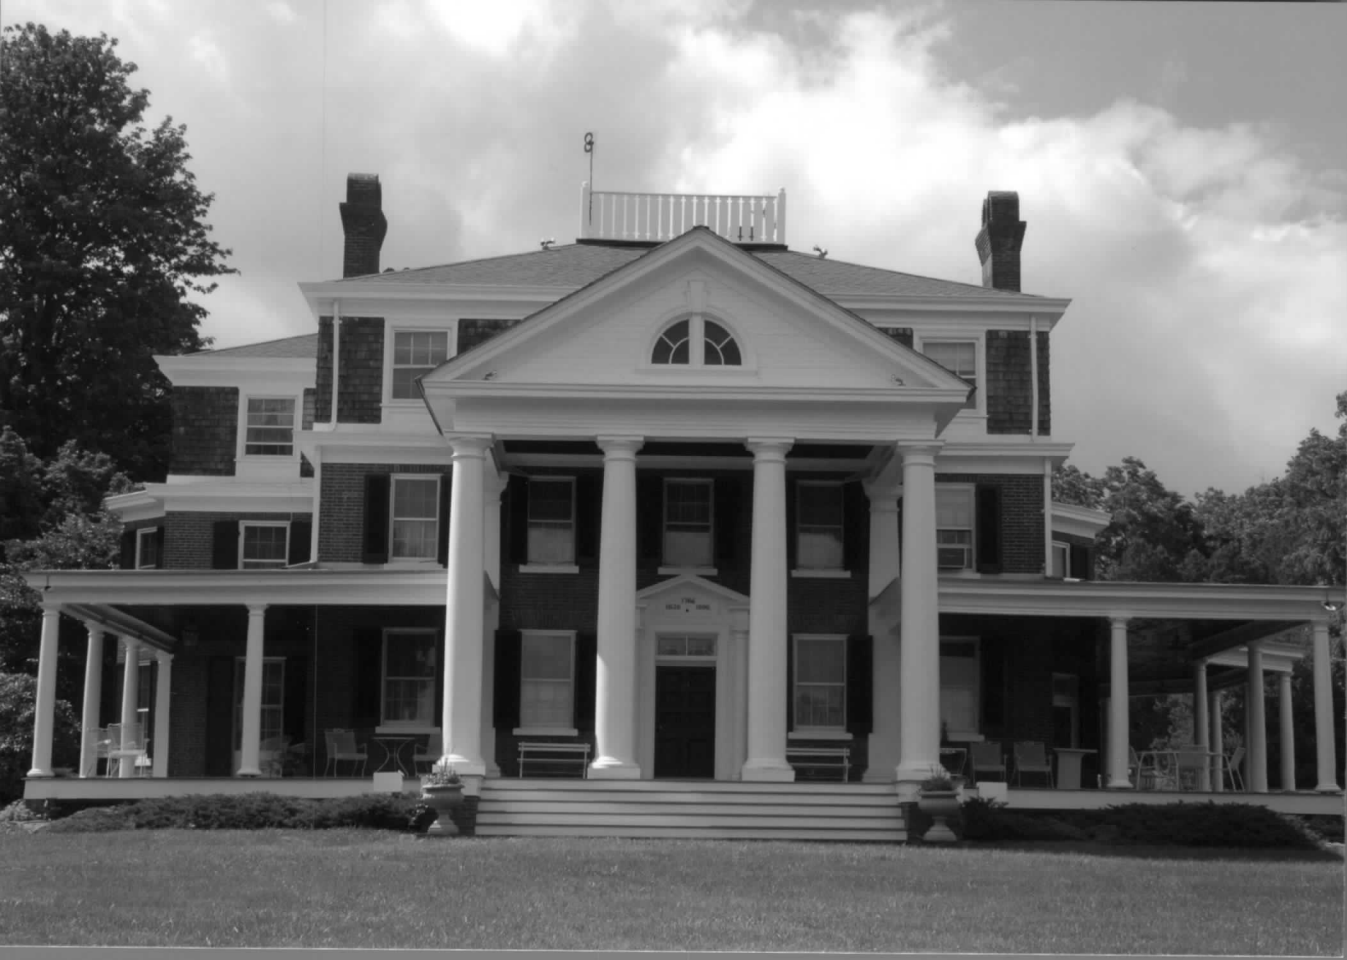
1 of 36

House, southeast elevation

The southeast elevation, on the first story, has a center door with eight panels that have sunken fields and quirked Greek ovolo panel moulds. There is a granite sill and one panel on each jamb and the soffit, with sunken flat panels and quirked Greek ovolo panel moulds. There is a leaded glass transom, and the transom bar has an ovolo at the top, a quirked Greek ovolo below with two fillets, and a bead at the bottom. The door architrave has a quirked Greek ovolo backband, a broken field, and an ogee on the inner edge; it is crossetted. There is a panel above the door with the dates "1766, 1838, 1898." To the outer side of the architrave are wood engaged columns with impost blocks and a pediment. There are two six-over-six sash to each side, with wood lug sills that have a wash, bullnose frames, and splayed brick jack arches. They have blinds with cast iron butt hinges. The second story has five six-over-six sash that match the first story. The center three bays have a two-story colossal portico with four Doric columns and two pilasters against the wall. It has a bead-board soffit that is stained dark brown, a full entablature, and a pediment with flush weatherboards and a lunette; the latter is divided by a large mullion into two three-light sash with a wood keystone. There is a one-story porch to either side of the portico that is set back from the portico and wraps around both sides. It has a tongue-and-grooved wood deck, Doric columns, a full entablature, and bead-board soffit. The porch is set on brick piers with lattice between them. There is a full entablature between the second and third stories. The third-story end bays have six-over-six sash with a panel below that is sunken and flat.

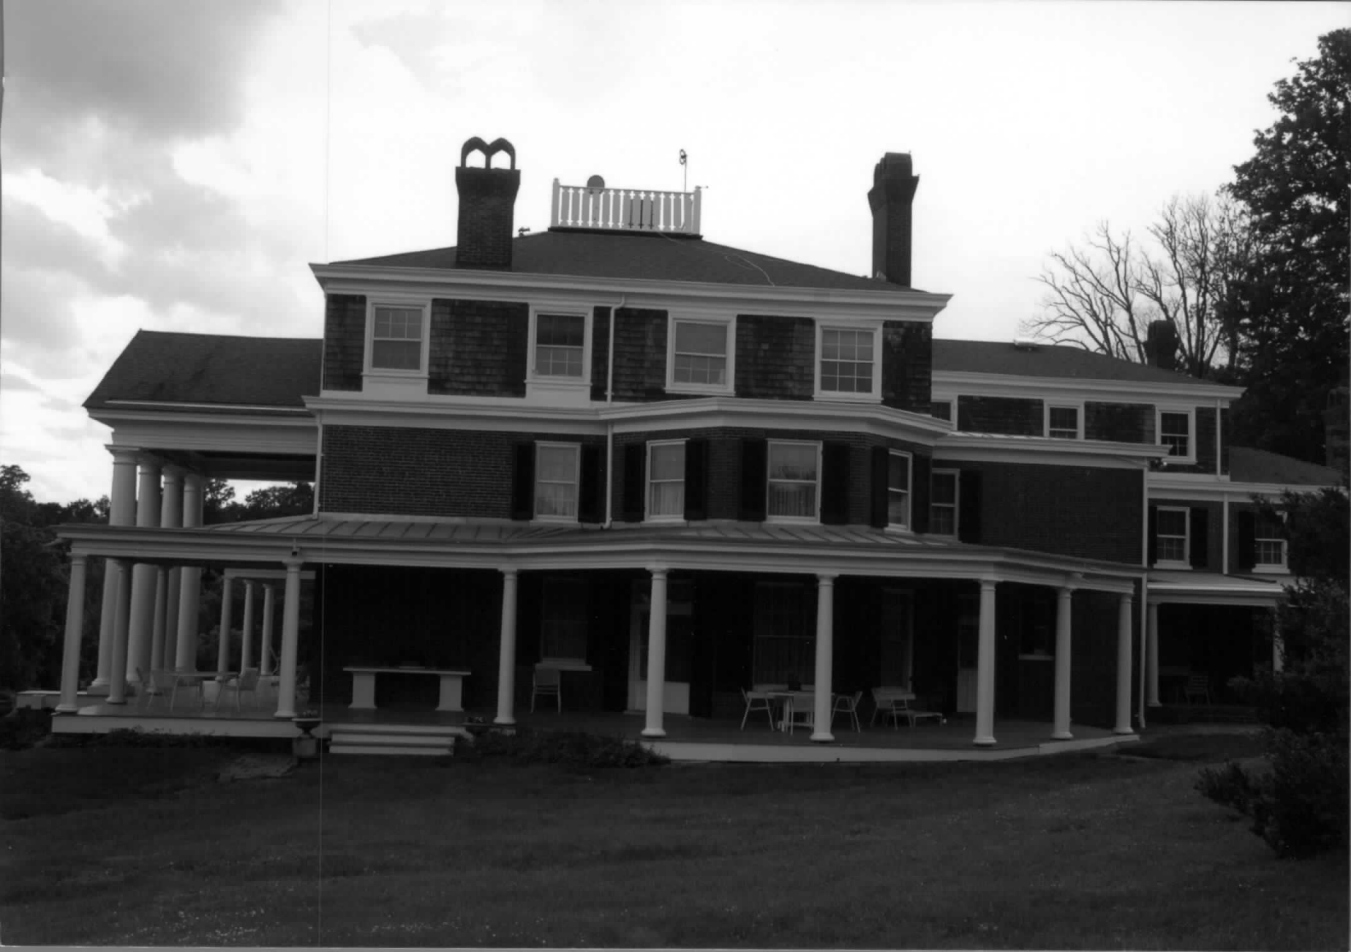
2 of 36

House, northeast elevation

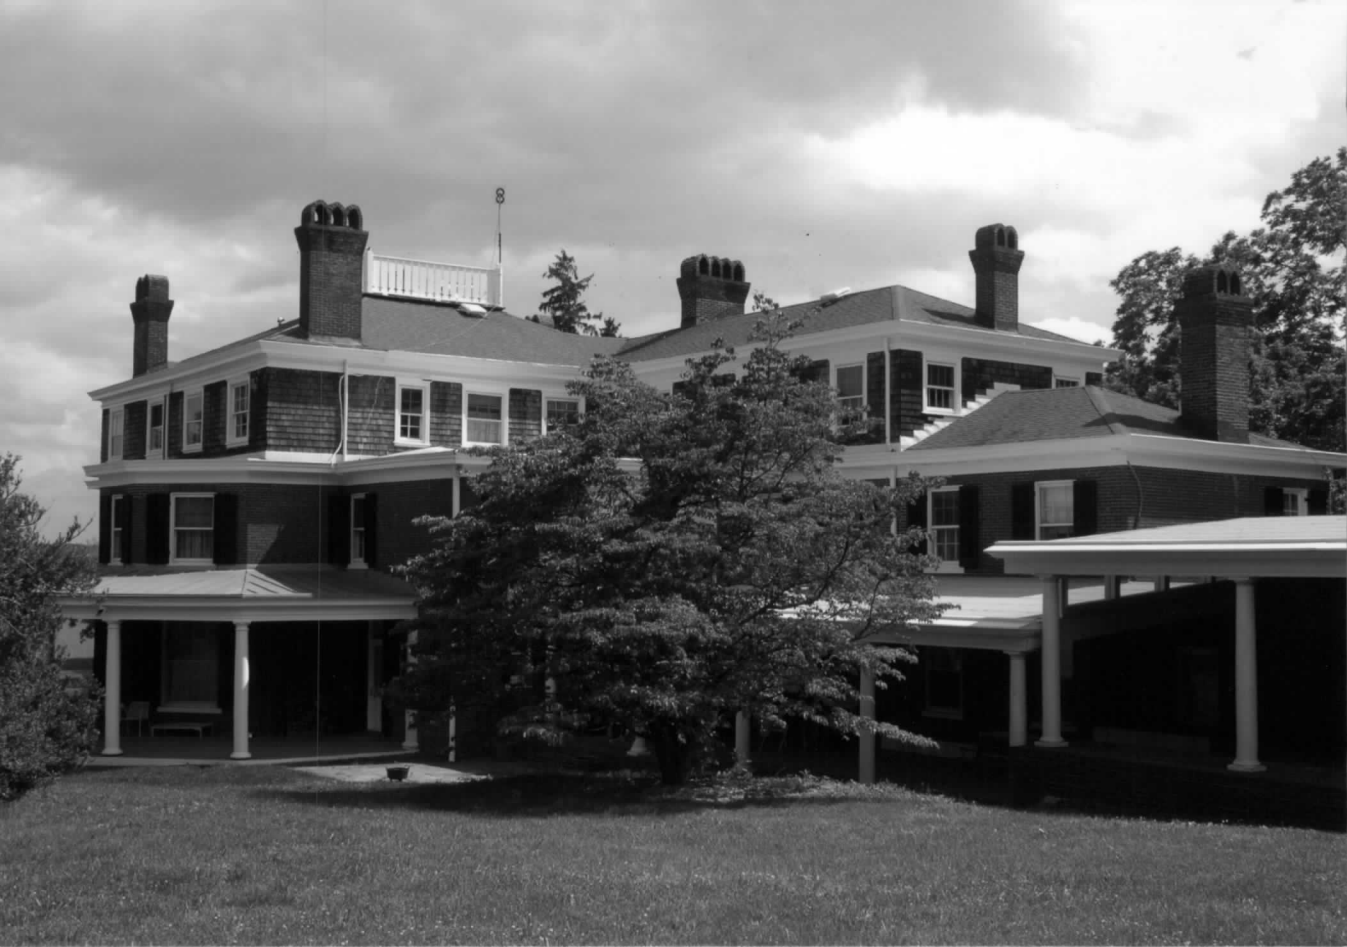
3 of 36

House, northeast & northwest  
elevations

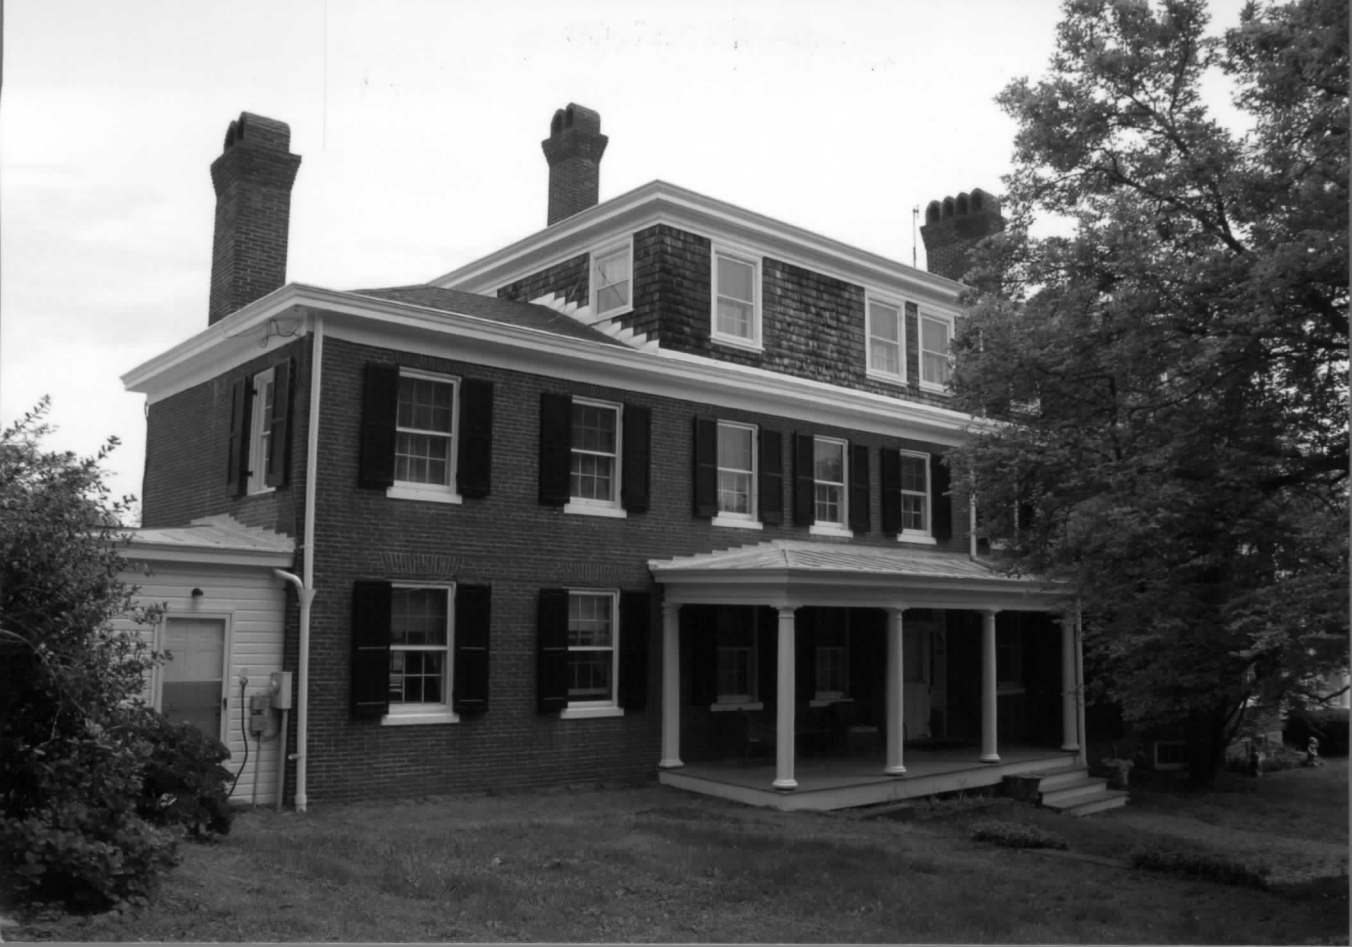
4 of 36

House, ell, southwest elevation

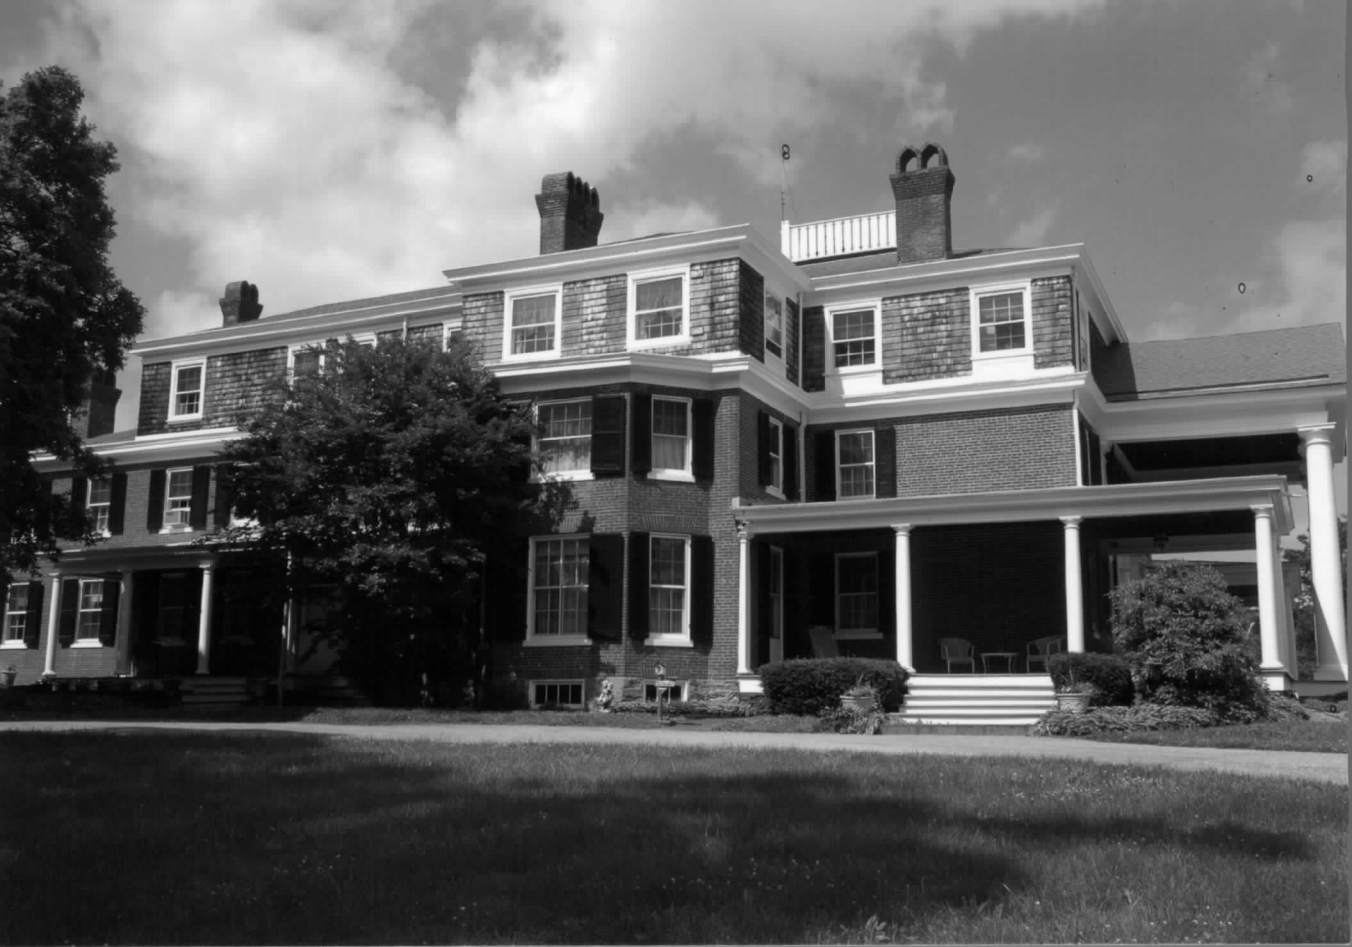
5 of 36

House, southwest elevation

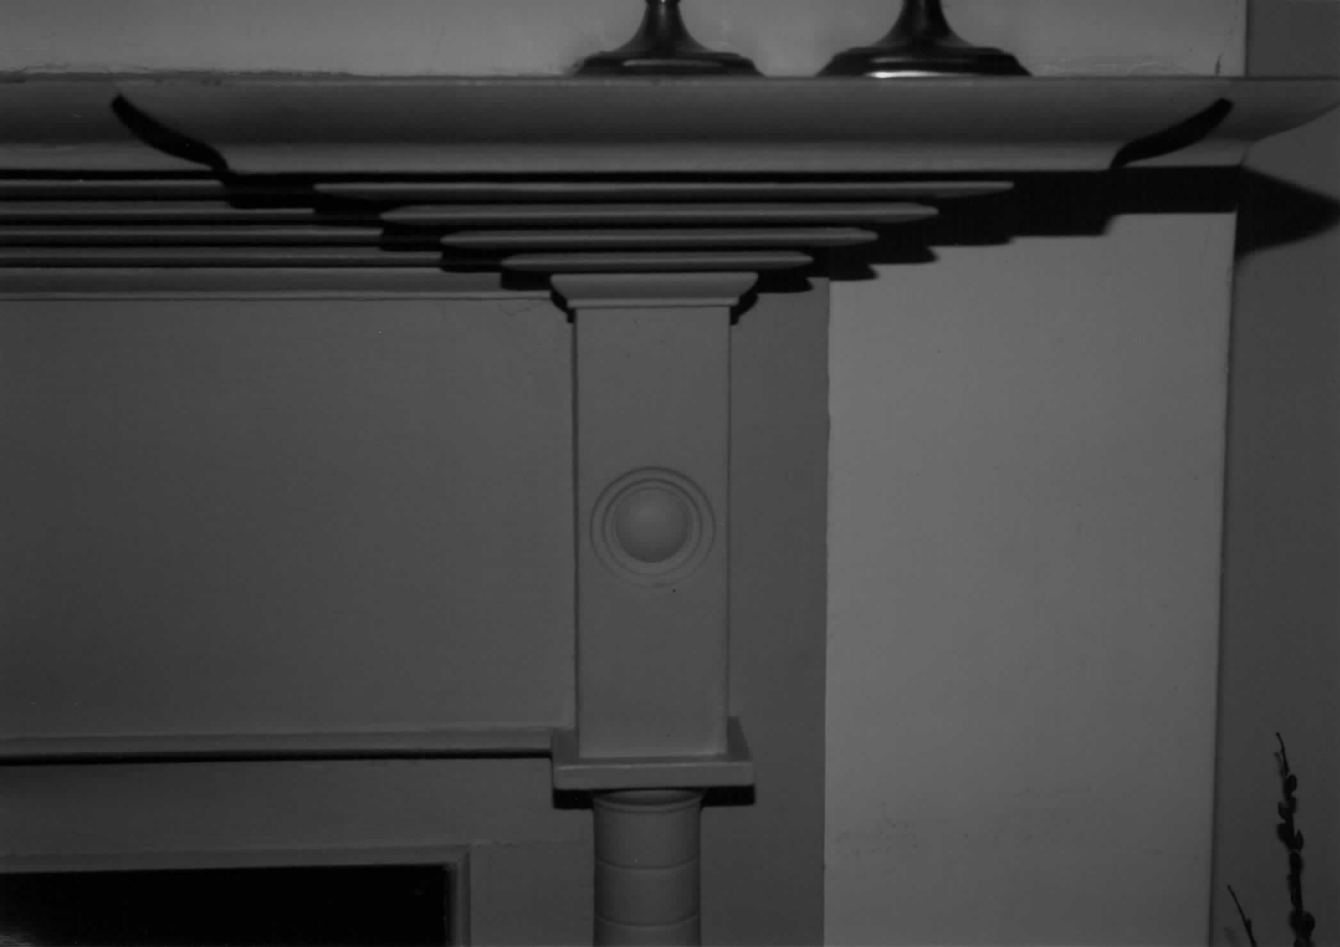
8 of 36

House, east room, mantel detail

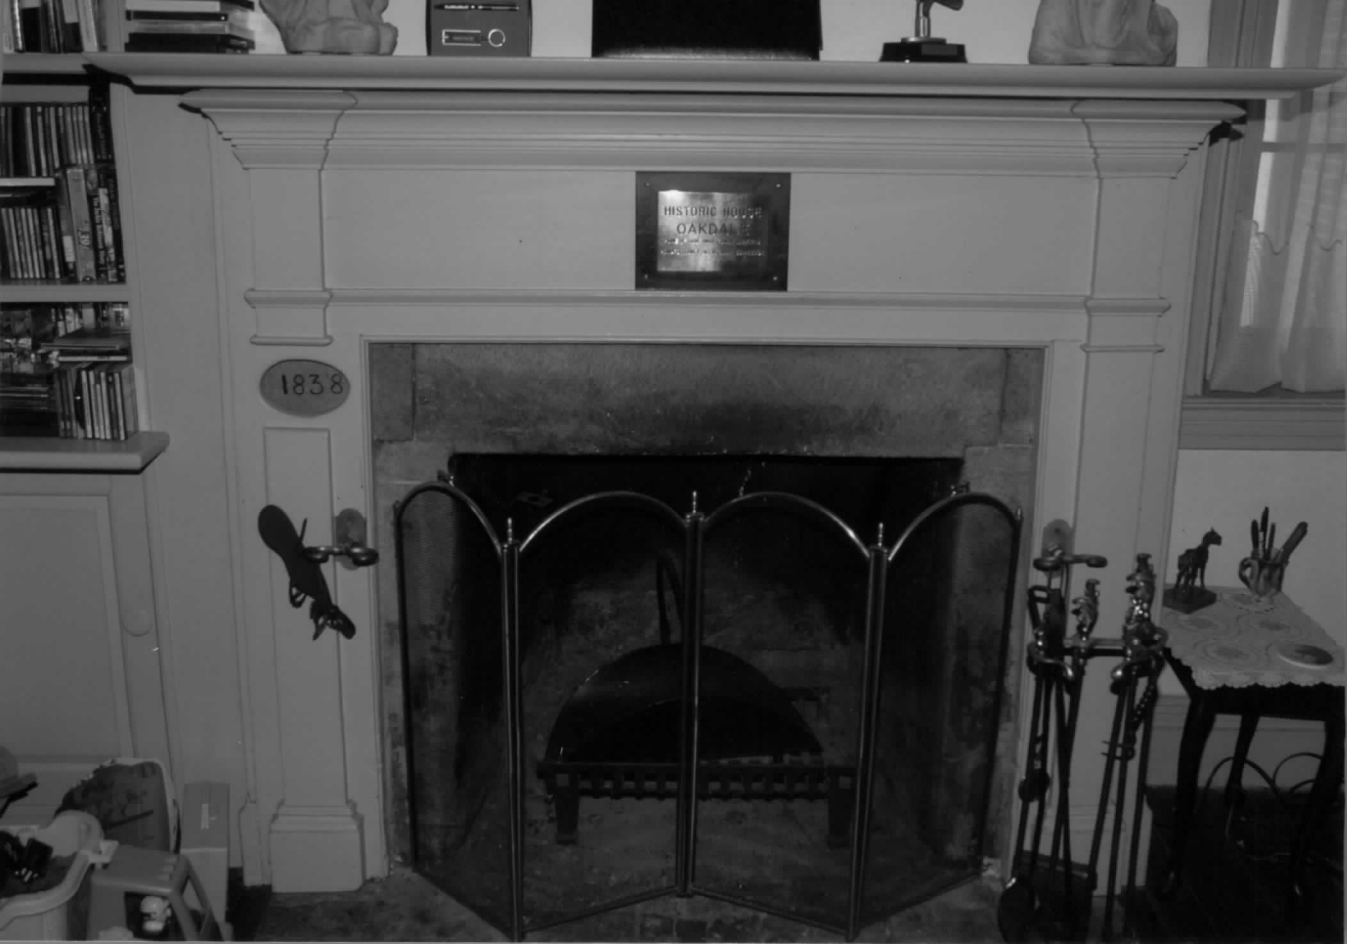
9 of 36

House, south room, mantel

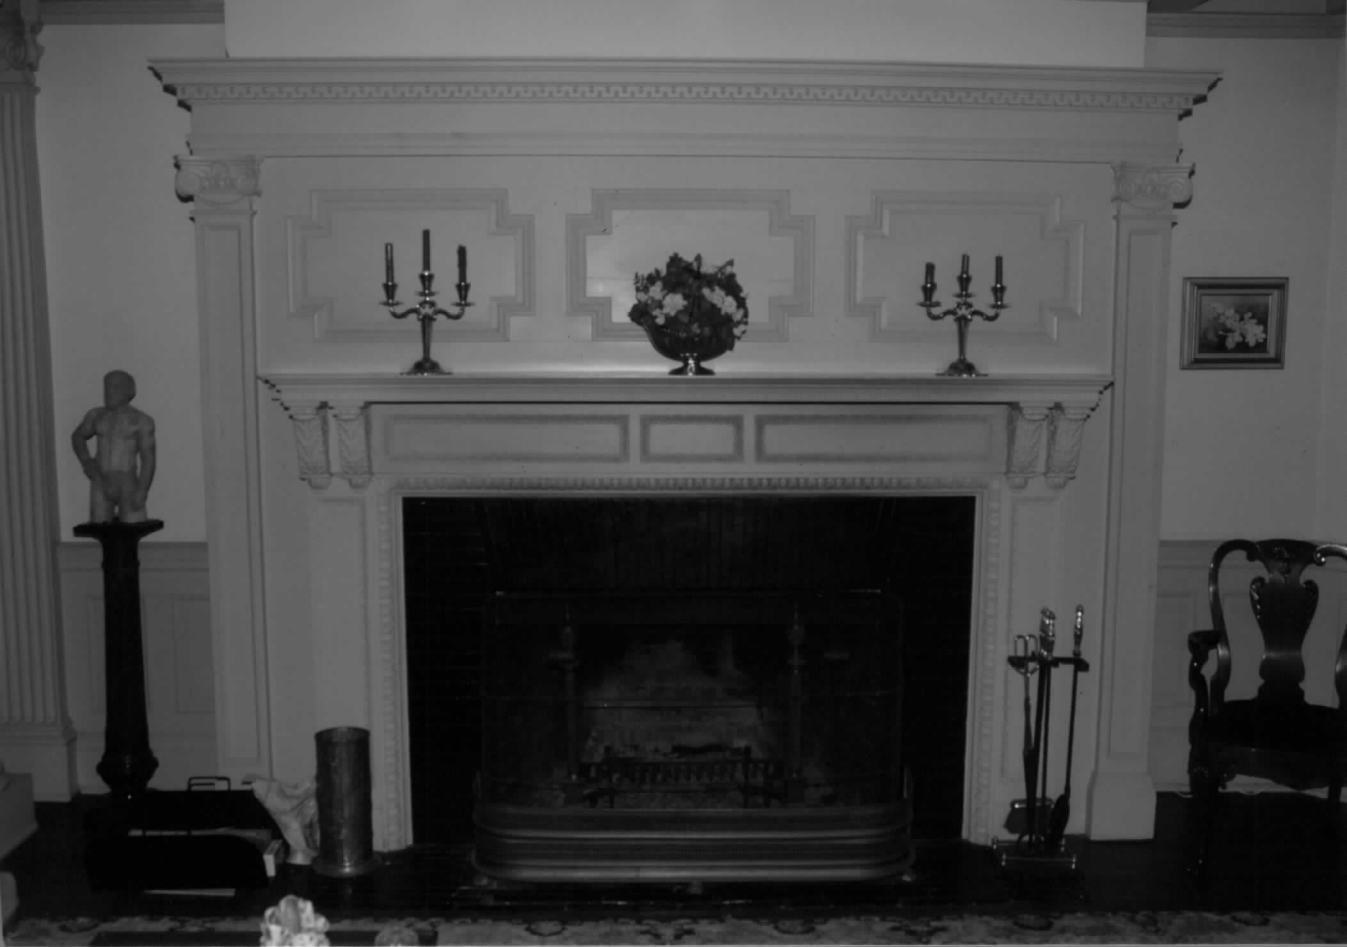
12 of 36

House, north room, mantel

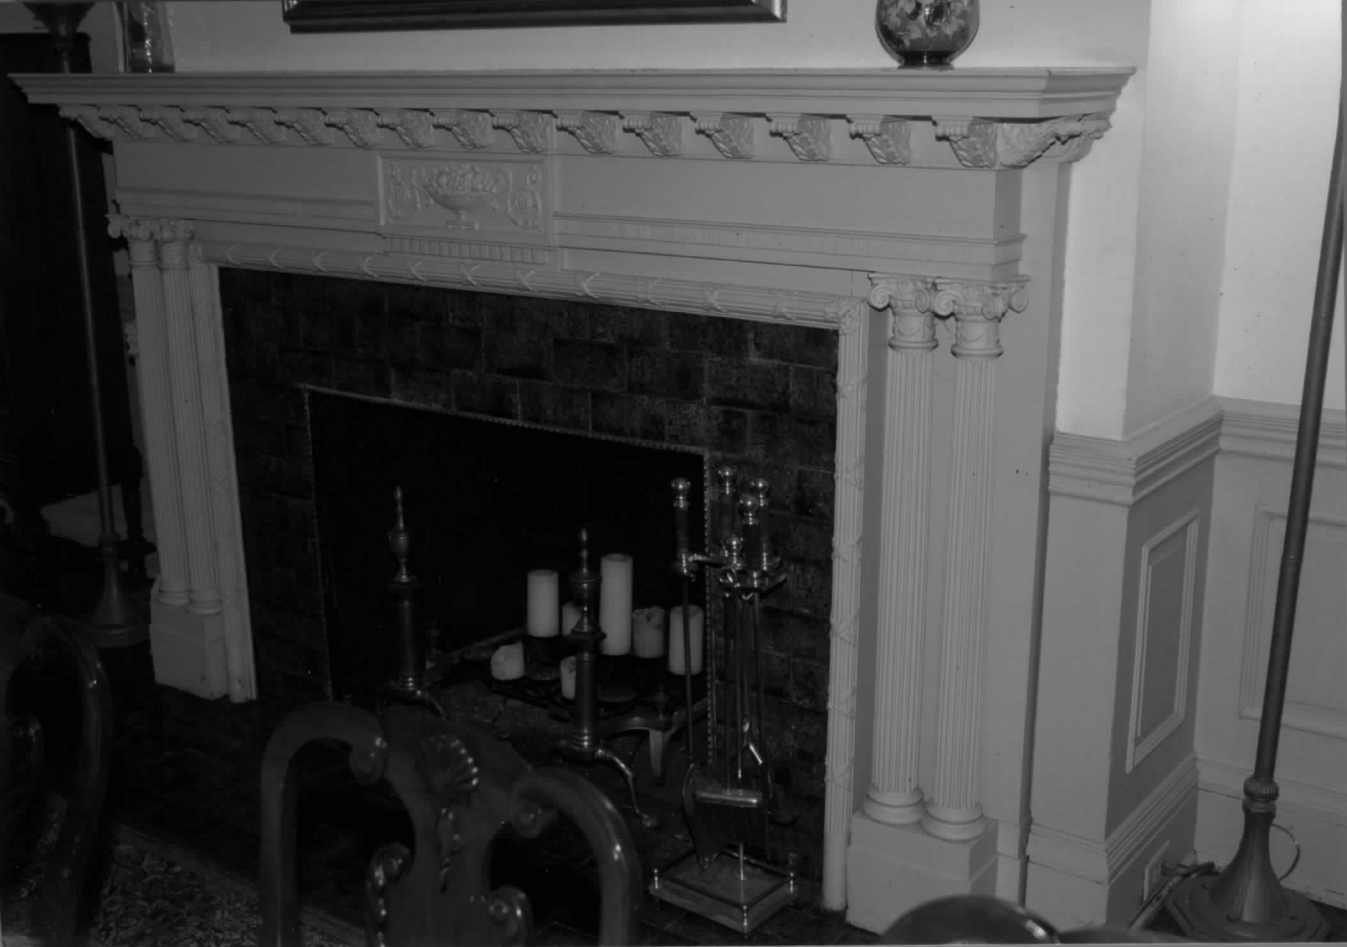
14 of 36

House, west room, mantel

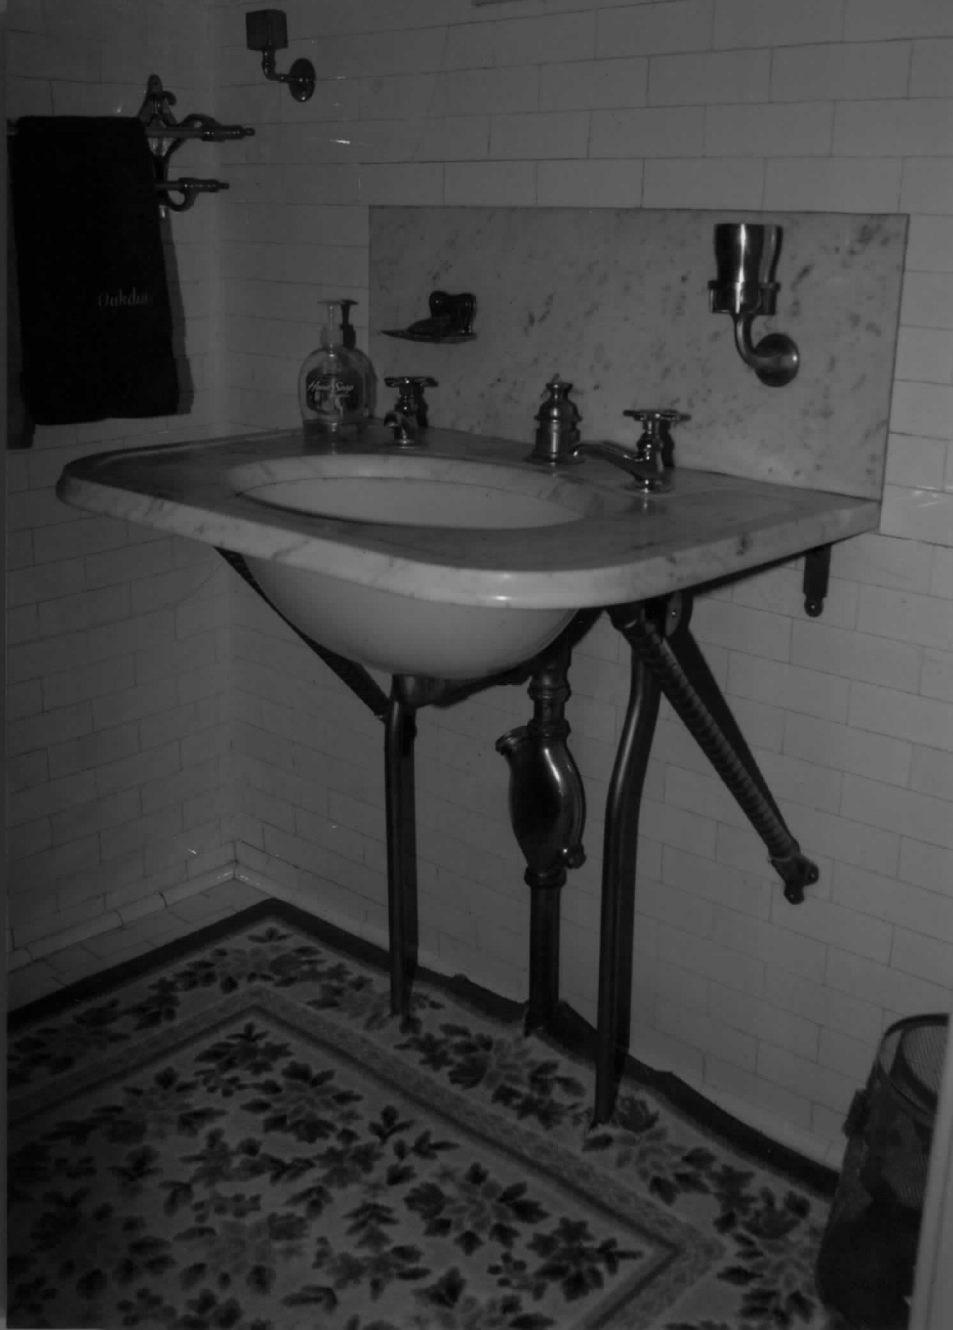
15 of 36

House, powder room sink

The powder room is divided in half, with the water closet in the northern half and the sink in the southern half. There is a doorway between both halves, but the door is missing. Both halves have white rectangular tile on the floor and walls, with the top course moulded with ribboned swags. The sink has a marble top and backsplash supported by twisted brackets with a nickel finish. There is a window on the northeast. The architrave is symmetrical, with two rabbets and

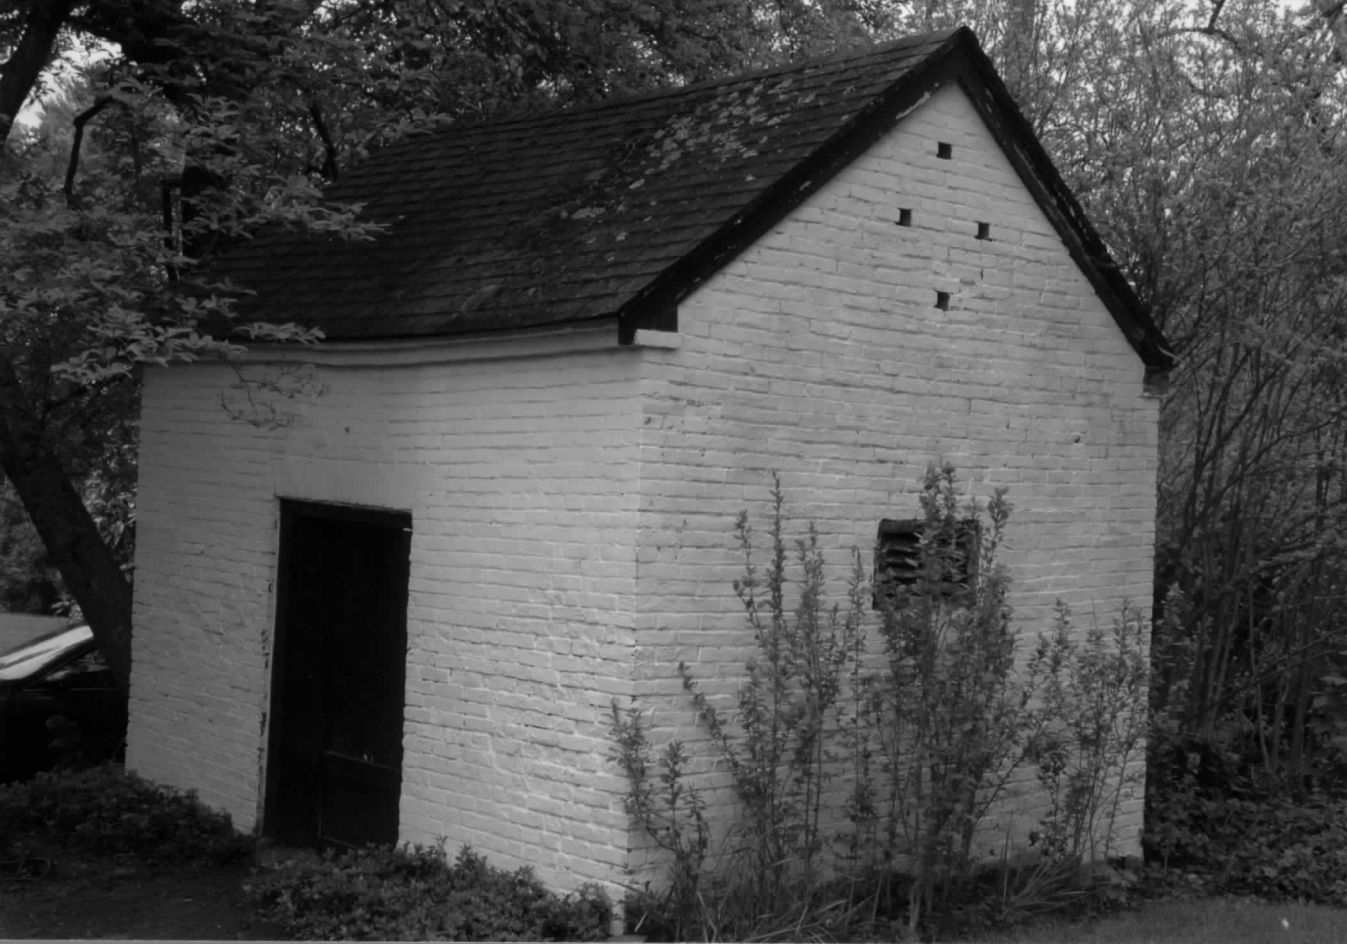
24 of 36

Smokehouse, northeast + northwest  
elevations

The interior walls retain parging on the top half, but below it the brick is deteriorated. The door is missing its lock and has a newer strap hinge at the bottom, with a wrought strap hinge at the top that is tapered and has a round end. There are four joists that appear to be sawn and have waney edges, but are also very fuzzy. They run northeast-southwest and are set into the brick wall about 2 feet below the top of the wall. Above them, sitting on top of a 1-inch thick board on the top of the wall, are five joists that run in the same direction. The three center joists have been cut out. They support a false plate. The rafters are sawn, appear to have a birds-mouth cut at the foot, and are set above the joists. They are half-lapped at the ridge, and no pegs are visible. They support shingle lath and circular-sawn wood shingles. There are two boards, one on each side, nailed across the rafters from the northwest end to the southeast end. They support short boards that are laid up loose across them, and each of these loose boards has three iron hooks in the bottom of them.

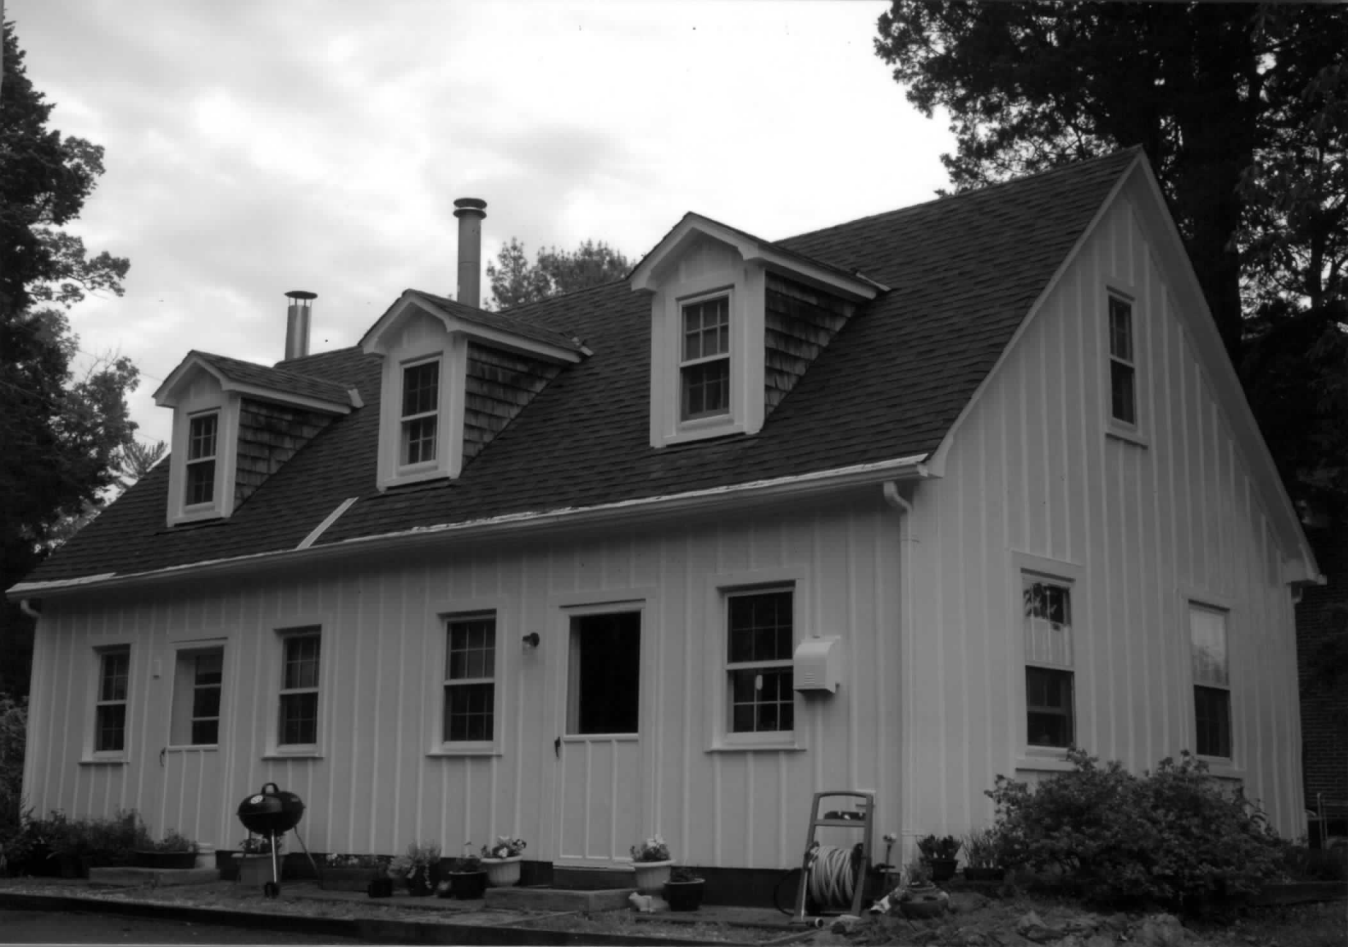
25 of 36

Carriage House, southwest + southeast  
elevations

The building referred to as the Carriage House is located about 75 feet west of the house ell. It is a 1-1/2 story, six-bay by two-bay frame structure with a parged foundation, board-and-batten siding that has an ogee on both sides of the batten, and a gable roof with asphalt shingles and a ridge that runs northwest-southeast. There is a wood box cornice.

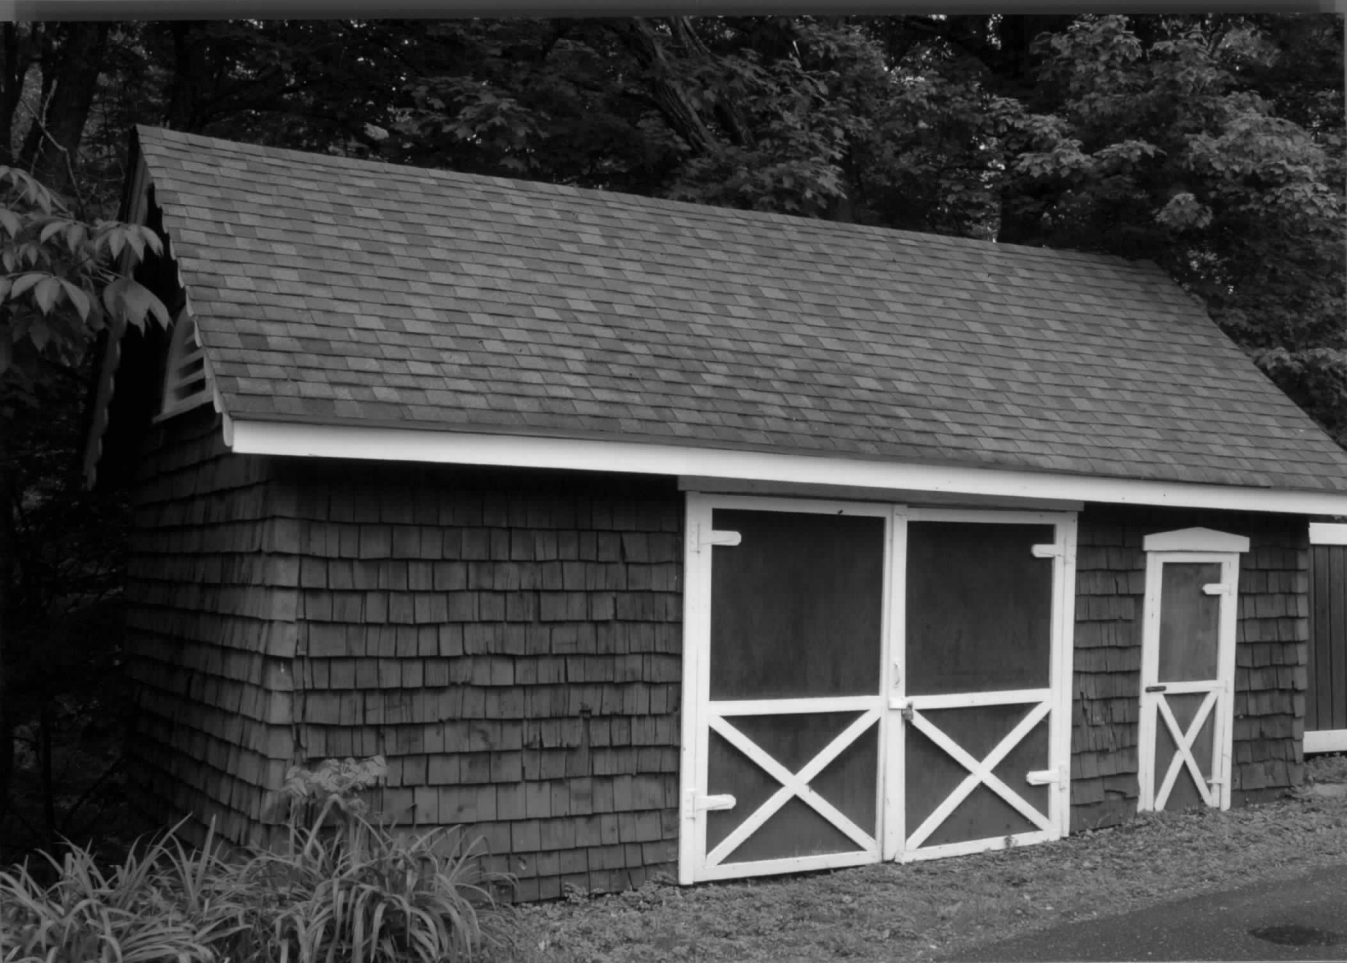
26 of 36

Garage, southeast + northeast elevations

The Garage is located about 30 feet west of the carriage house and is banked into a hill that slopes steeply down to the southwest. It is a one-story, three-bay by one-bay frame structure with a poured concrete foundation, wood shingle siding, and a gable roof of asphalt shingles with a northwest-southeast ridge. It has a boxed eave with the soffit sloped to the pitch of the rafters.

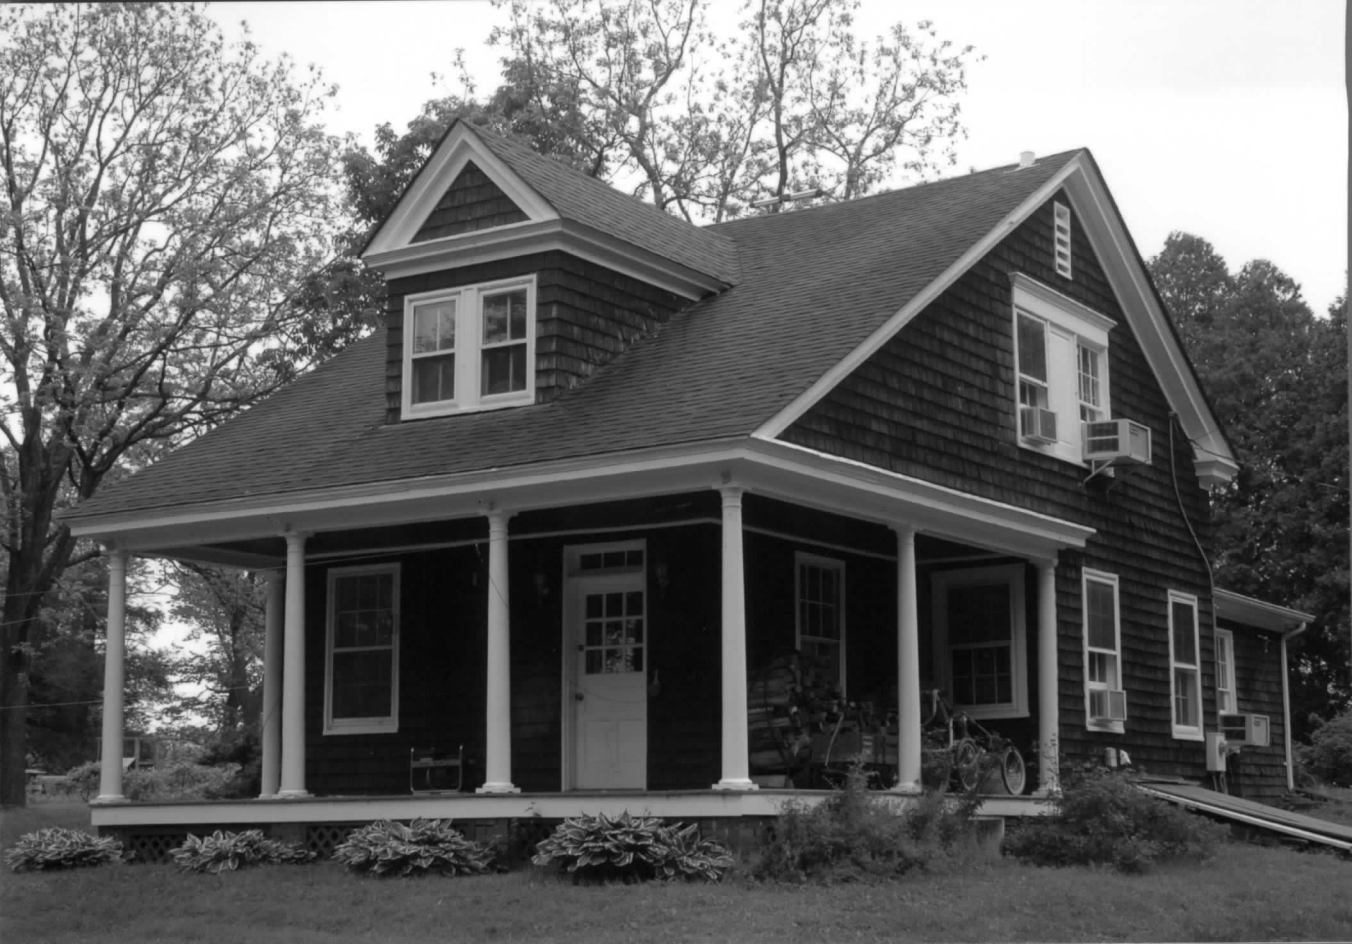
27 of 36

Gardner's Cottage, northwest +  
southwest elevations

The Gardener's Cottage is located midway between the main house and Ed Warfield Road, and faces northwest toward the road. The drive from the road circles around the southwest side of the cottage. This is a 1 1/2-story, three-bay by three-bay bungalow with a rubble stone foundation, wood shingle siding, and a gable roof with asphalt shingles and a ridge running northeast to southwest. There is a one-story ell on the southeast that is two bays by two bays, with matching foundation, siding, and roofing. The gable roof ridge runs northwest-southeast, and there is a large exterior stone fireplace and chimney on the southeast end.

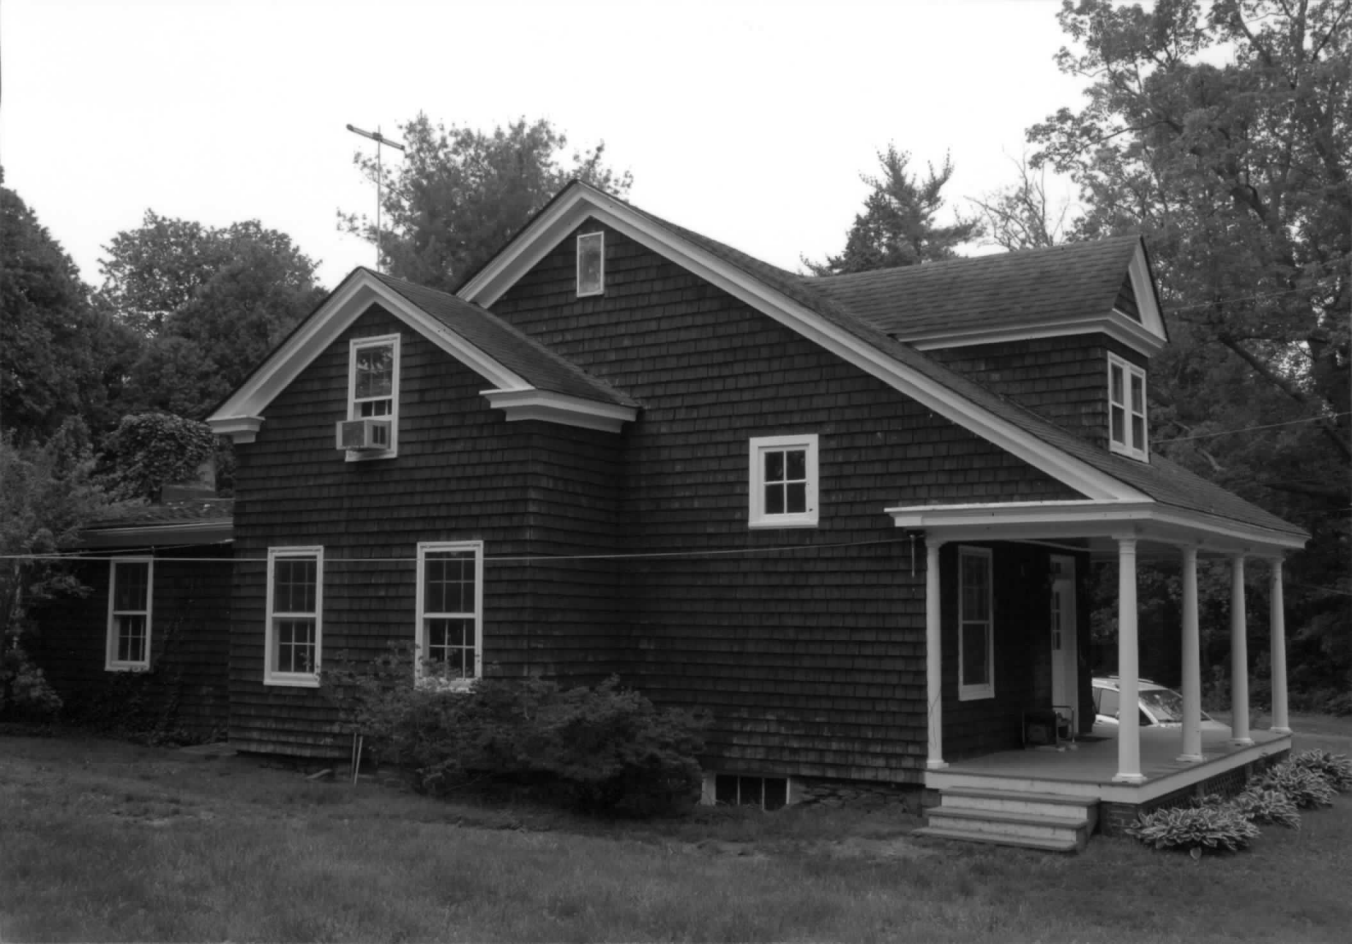
28 of 36

Gardner's Cottage, northeast &  
northwest elevations
